DOCUMENTATION AND ARCHITECTURAL ANALYSIS
OF LITTLE MANOR PLANTATION HOUSE

William Luby Ferguson

A THESIS

Historic Preservation

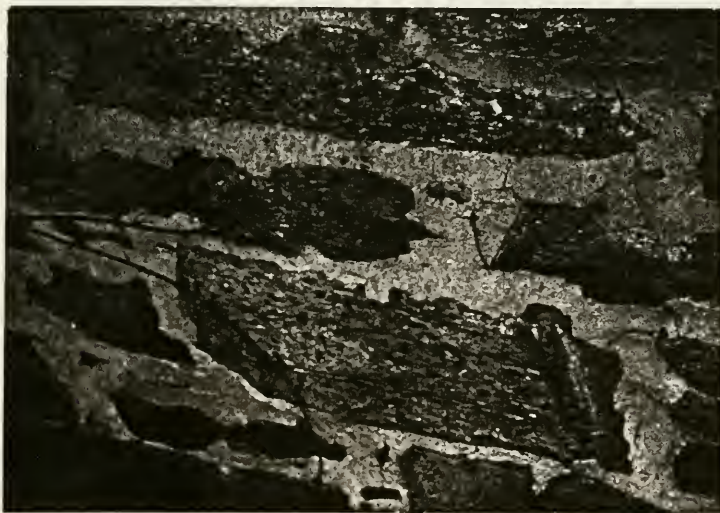
Figure 10: Gneiss Foundation Below Main Door of North Elevation

In both the Federal and Georgian period sections, the foundation is made of wet laid rubble and some cut stone. The stone appears to be a type of tan colored gneiss and was also used for the base of the Georgian chimney and most of the components of the Federal chimneys. The foundation walls rise about four feet above grade on the exterior. The walls in the basement areas vary in height from about seven feet in the Georgian section, to four feet under the cross hall. Lime mortars were used in the joints, and were struck to form a crude ribbon design. The photograph below shows a section of the foundation below the main portico. The spots in the middle of the picture are some type of oxidized ferrous material.

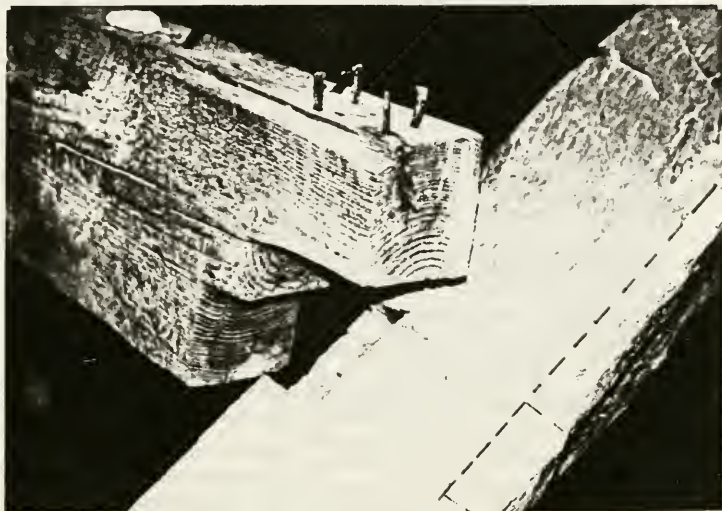
Figure 12: Federal Section Joist and Sill

It is a variation of a shouldered tusk and tenon joint, where the joist laps onto the sill. When the joint is connected, there is a four to five inch gap between the outside of the sill and the joist end, illustrated by the dotted line. Unfortunately, this sill is brown rotted, and normally is twelve inches wide rather than the eight inch width seen. The dotted area represents a band on the outer edge of the sills and plates on which all of the vertical framing members are placed, connected by mortise and tenon joints, and in some cases, nails for secondary studs. The joist is four inches thick and nine inches high. For the purpose of identifying the location of photographed framing details, the Figure Numbers of the photographs match the circled numbers on the framing drawings.

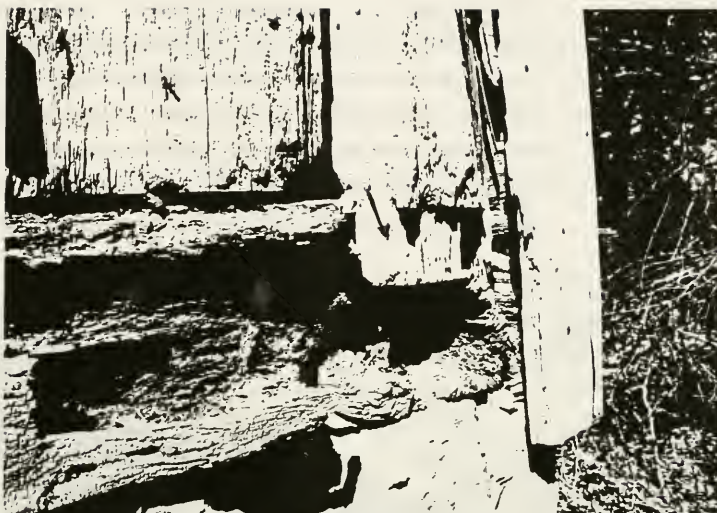
Figure 15: Federal Section Northeast Corner Connection

The complexity of the corner post and sill connections are shown in Figure 15. The photograph is taken at the northeast corner of the Federal section. The rotted sill (center left) is a twelve-by-twelve which receives the tenon of the corner post. A second mortise and tenon joint is located at the intersection of the east sill and the north sill, but this is not visible. In addition to having hidden joints, these connections were also difficult to analyze because the sills and plates differ in size and in the planes of their connections. This is illustrated in the oval shown at the northwest corner of the north elevation drawing. The vertical cross section member (center left in oval) is the west second floor top plate, a four-by-twelve. It is mortised and tenoned into the massive north plate and rises three inches above it, to the same level as the top of the joists.

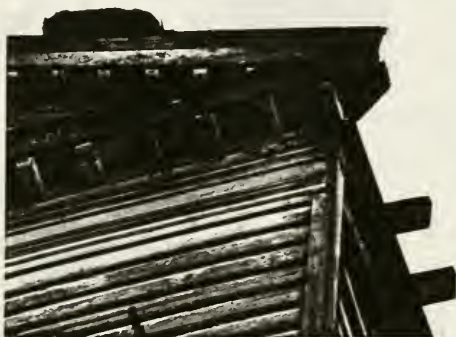
Figure 48: North Elevation; Trim Elements of Federal Main Gable

Matching the high style theme of the principal elevation first floor window surrounds are the modillions and molded components of the massive gable roof. The modillion blocks measure four by eight inches and are spaced about ten inches apart. In the appendix are two detail

drawings of these features, but the modillion profiles as shown are incorrect. Figure 48 shows the northwest corner of the main massing. As the modillions project from the building, there is a plain block that is interrupted by a fillet, then the profile curves upward in a quarter round configuration. The picture shows a cyma reversa molding below the modillions interrupted by a fillet. Also shown are a small rake board molding and corner boards, which have a roundel molding at the corner. The silhouettes of a dragon beam and projecting attic joists are visible to the right.

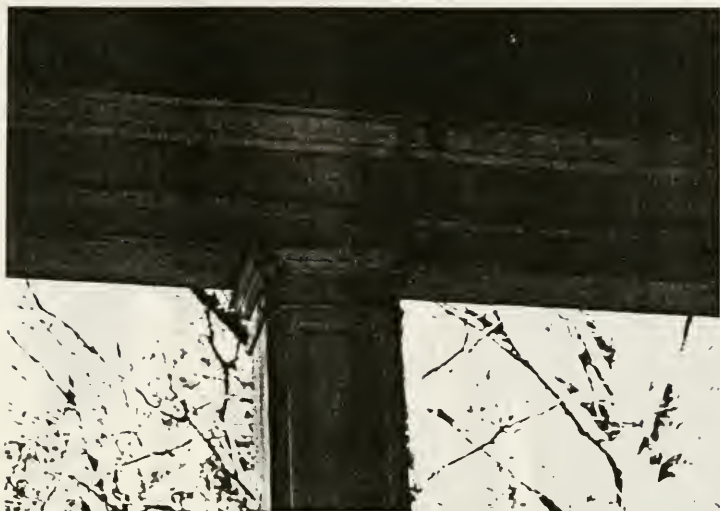
Figure 49: Detail of Main Portico Pier

Most of the ornamental details of the main portico are missing, but two of the square columns are still in place. They are stylized versions of the Doric order, with pilasters superimposed on the inner and outer surfaces. Figure 49 shows one of the two surviving columns and Figure 50 shows the portico and part of the principal elevation as it appeared around 1940. From these two photographs, it can be seen that the portico resembles that of the main gable, but with scaled down components. The balusters are thick and may be original features. The portico ceiling is narrow tongue and groove and the flooring wide tongue and groove.

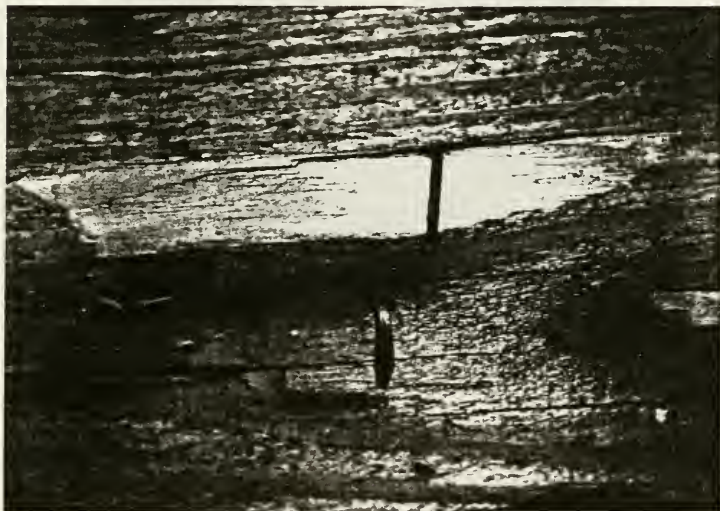
Figure 53: Wrought and Cut Nails in Georgian South Chamber Roof Sheathing

The sheathing boards for the roofs of both sections are wide planks with one inch thicknesses, except in the cross hall, where the sheathing has been replaced with sheathing lath. Nail patterns in the sheathing indicate multiple campaigns of roofing. The next figure shows nails protruding from sheathing in the Georgian south chamber. A wrought nail with a spoon-tipped shank is seen in the lower middle part of the picture, with a cut nail above it. The sheathing of the Federal main roof has early cut nails with handmade heads. In both cases, the sheathing is likely original material.

In addition to these nails, there are modern wire nails of later campaigns, but oddly, no machine-headed cut nails or modern cut nails which one would expect to see for roofs installed in the middle and late nineteenth century.

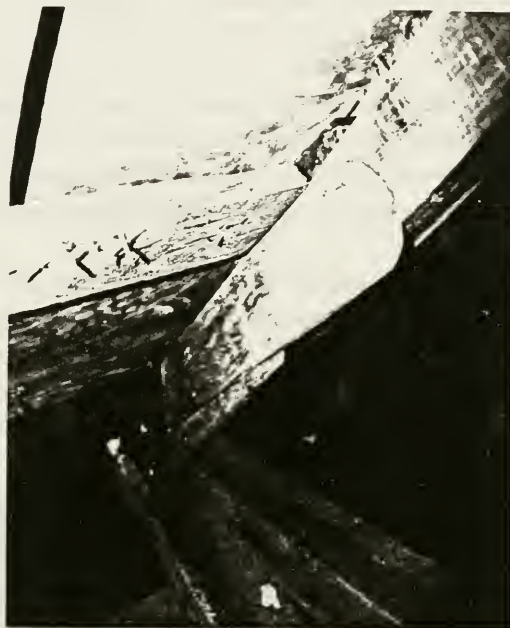
Figure 54: Oak Roof Shingles in Cross Hall Attic Space

In the process of removing roof sheathing boards from the cross hall, the carpenters decided to use old wood shingles as nailers for the purlins. Seen in Figure 54, the shingles are made of oak, are about five inches wide and a one-half inch thick at the exposed ends. The ends are

scalloped, a common feature of shingles in the eighteenth and early nineteenth centuries, designed to prevent warping. When these shingles were installed for roofing purposes is unknown, because of the absence of embedded historic nails. Wood shingles rarely last beyond forty years, but it is possible these were leftover from the original construction date and had fallen into the attic space. In the Federal section, scalloped pine shingles were discovered in the main gable roof structure but when they were originally used is also unknown.

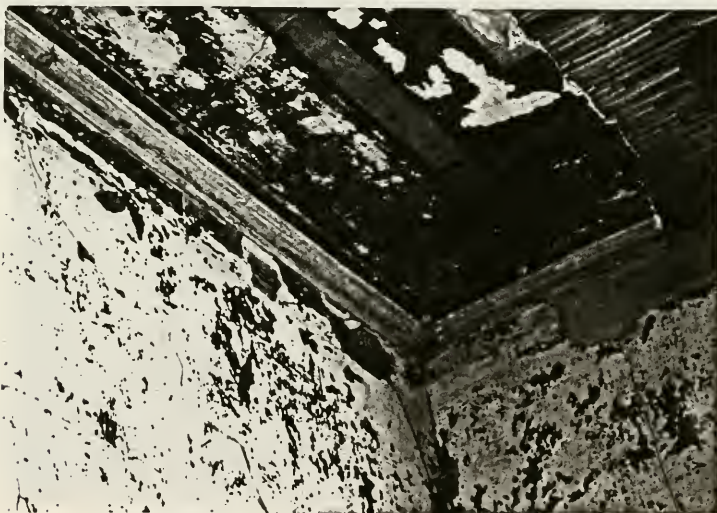
Figure 55: Paint Finishes in Federal East Parlor

A good example of this is provided by the Federal east parlor, the only room in the building other than the Georgian parlor with nonwhite paint on the plaster surfaces. Figure 55 shows the ceiling area at the northwest corner of the room. Part of the elaborately painted ceiling is still intact, but most of the paint has flaked off the wall surfaces. As will later be seen the Frances Benjamin Johnson photographs, the paint finishes in this room were the most elaborate in the building.

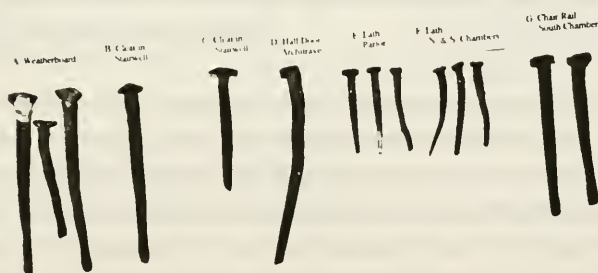
Figure 71: Representative Nail Types of Georgian Section

The dominant nail type used in the Georgian section of the building is the hand wrought nail. Shown in Figure 71, these nails were used for framing elements, weatherboard, exterior trim, second floor interior trim, and flooring. These are represented by labels A, B, C, and G.

All of these Type I nails are two to three inches in length, have spoon-shaped shanks at the ends and have either T-shaped or rose-shaped heads. Of the non-lath nails partially or completely accessible for visual examination, approximately 85% were of the hand wrought variety. The other 15% were completely machine-cut brads used exclusively for first floor interior trim elements. Brads are defined in the eighteenth century as non-framing nails over two inches long, whereas sprigs are nails under two inches, such as lath nails. By the early nineteenth century, brads referred to any non-framing nail. In Figure 71, the completely machine-cut brad is represented by label D. Since this is a Type III nail, produced from 1805 to 1820, it indicates that the trim elements of the first floor of the Georgian section are contemporaneous with the construction of the Federal section, sometime after 1804, the date the estate was transferred to William Person Little.

In terms of chronology, the most interesting nails are the lath nails used in the Georgian section. The lath nails shown as labels E and F in Figure 71 are either Type IIC or Type IV, (early machine-cut nails with handmade heads and early machine-headed cut nails). Most of these are Type IIC nails, produced from 1790 to 1810. This indicates that the lath and plaster in the Georgian section was installed several years after the original construction date of 1781, the time the property was transferred to Thomas Person. It could also indicate that the Georgian section was built in the 1790s. In the deed and will research literature, it is constantly assumed that individuals would immediately build on their newly acquired properties, but there is no actual evidence to support this. Person may have decided to build the structure many years after inheriting the property, bearing in mind he already had a residence in Granville County. In regard to the existence of Type IV nails (1815 to 1830), it is likely they were used for minor alterations or repairs. The absence of completely hand forged nails for lath continues to surprise the author despite the theory just put forward. In the analysis of nails of Little Manor, this is one area that needs further investigation. It does, however, indicate that technology transferred quickly to Little Manor from the more heavily populated coastal settlements.

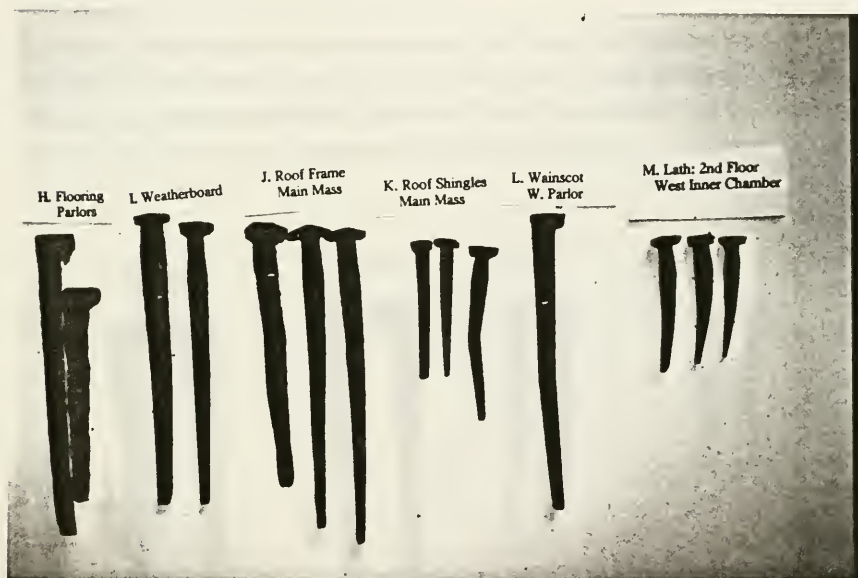
Figure 72: Nails of Federal Main Massing

Analysis of nails in the other sections of the building are less complicated. In the Federal main massing, the nails used in the weatherboard and roof frame are Type IIA nails, early machine-cut nails with handmade heads. Shown under labels I and J (the two to the right) in Figure 72, they were produced between 1790 and the mid-1820s, which fits the time frame of the construction of the main massing sometime after 1804.

Approximately 80% of the framing nails examined in the Federal main massing are of the Type IIA variety. The other 20% are wrought nails used for clinching purposes in braces (Label J, on the left) and some of the small framing members. For roof shingles, sheathing boards, and lath, the nails used were Type IIA and Type IIC. Type IIC nails were manufactured until 1810, so this is compelling evidence that William Person Little built the

The fourth main nail type in the Federal main massing is Type III, completely machine-cut brads, produced between 1805 and 1820. These nails match the trim nails used in the Georgian section and are seen under label L in Figure 72. The flooring nails of the main massing are identical to the trim nails and are seen under label H. They appear slightly oversized because of their corroded condition.

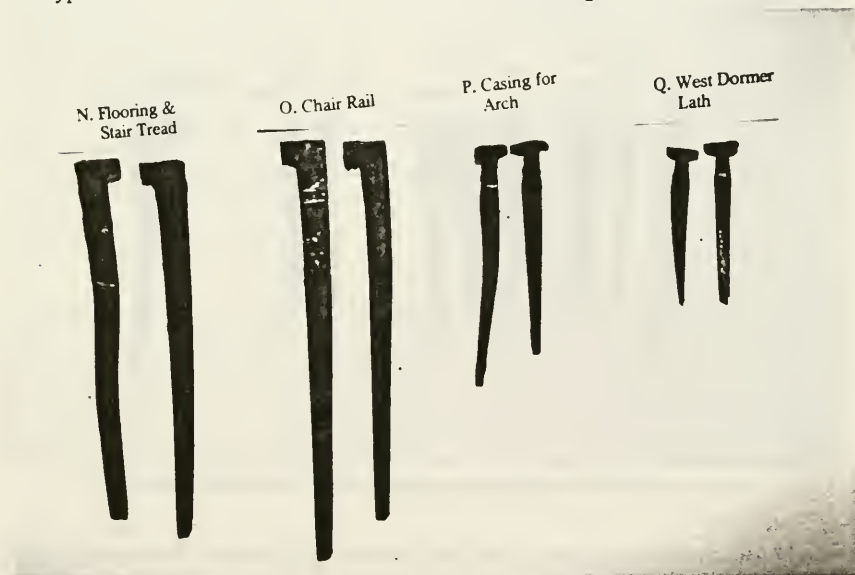
Figure 73: Nail Samples From Cross Hall

Nails taken from the cross hall area match those of the Federal main massing, which indicates the cross hall was built at the same time as the main massing. Shown in Figure 73, they are Type III nails (labels N and O) and Type IIA and Type IIC nails (labels P and Q). The Type III nails are used in all first floor sections of the building.

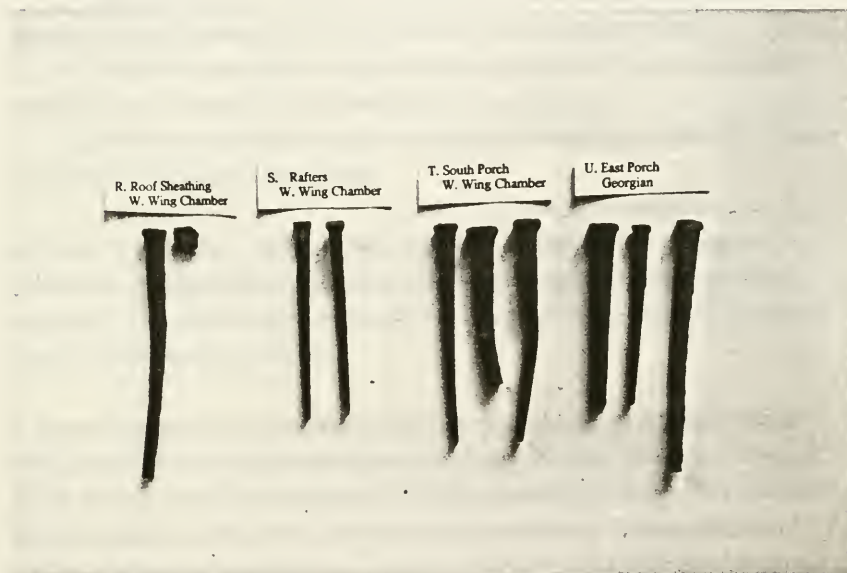
Figure 74: Nails of Rear Porch Structures and Federal West Chamber Roof

All of the porches other than that of the Federal main portico are in a state of collapse, but sections of these structures are still intact, lying on the ground. About 75% of the surviving nails of the framing elements and weatherboard for the fallen porches off the south elevation of the Federal section and east/west elevations of the Georgian section are built with Type IV nails and there are no earlier cut nails. It is likely that these porches and the Federal wing chamber roofs were constructed at some point after the introduction date of these nails after 1815. A few of these nails are shown in Figure 74.

Type IV nails are the one nail type which the author believes Nelson's time frames for their production are inaccurate. The author has seen nails of this type used as the primary fastener in building's known to have been constructed in the 1840s and early 1850s and he has seen this in more than one region of the country. It is doubtful that all of these machine-headed cut

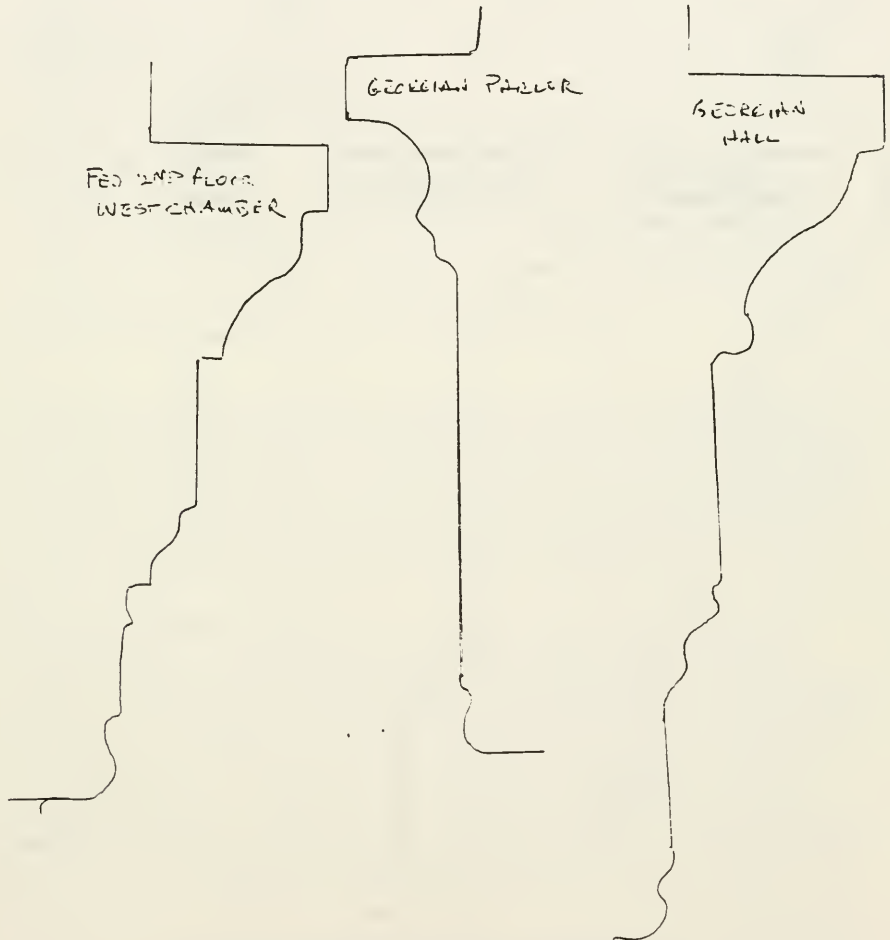
Figure 75: Molding Profiles of Little Manor

Within rooms, the profiles match from one door surround to another, but no two profiles match when comparing one structure to another. Figure 76 show several profiles obtained by the North Carolina SHPO of other structures in North Carolina.

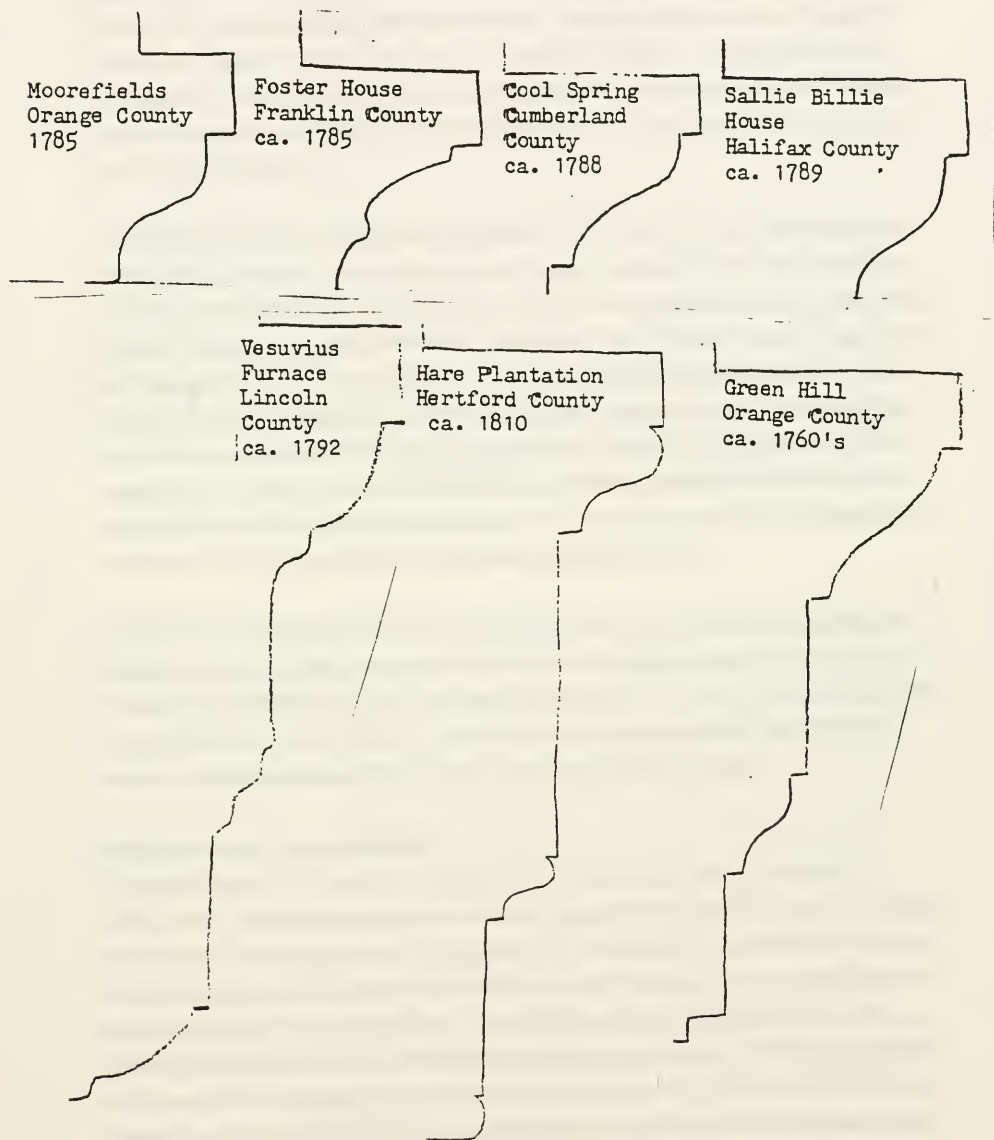
Figure 76: Molding Profiles of North Carolina Dwellings

The Georgian section hall and Federal second floor west chamber door profiles closely resemble other structures built between 1771 and 1798 in the contours of the band moldings. After 1798, the band moldings differ dramatically. Of particular interest is the comparison between the Federal chamber profile and the Georgian hall profile. They are quite similar, although the Federal chamber profile is scaled down. The Georgian parlor profile is unique in that has cavetto contour below the top fillet rather than the cyma reversa molding common to most of the other profiles.

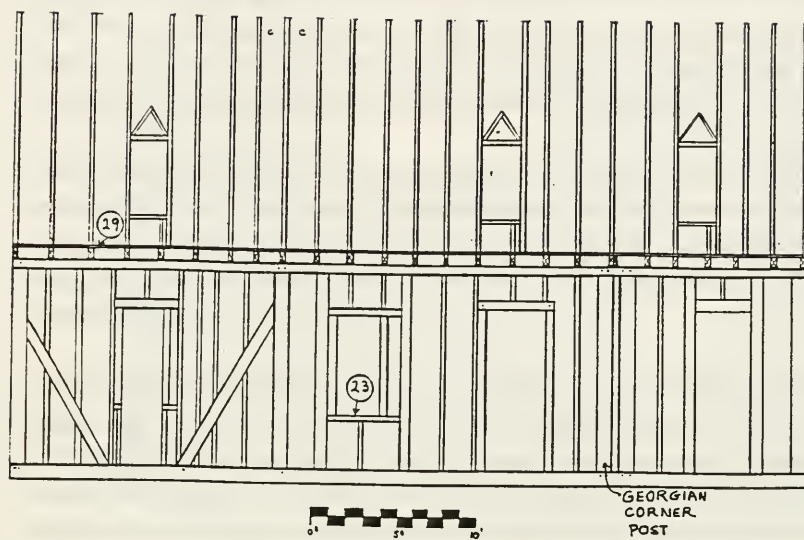
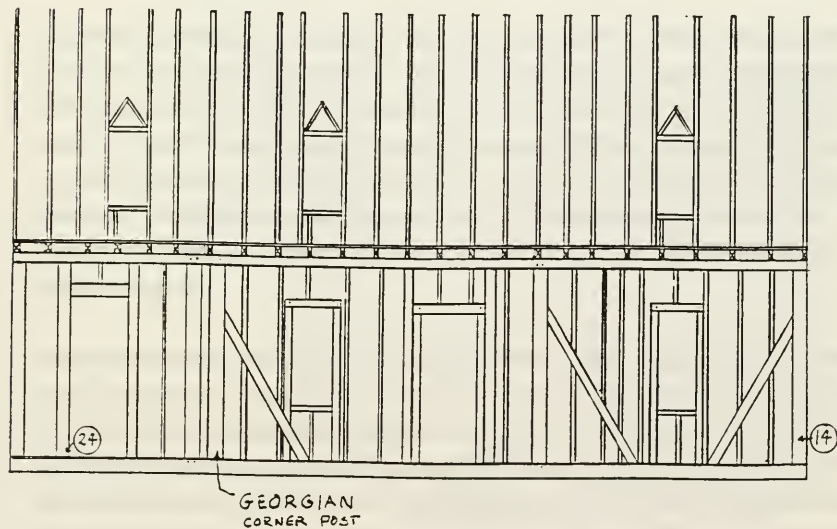
Figure 77: East (top) and West (bottom) Elevations of Georgian/Cross Hall Section

far left of the east elevation, it can be seen that the opening was converted from a window to a door. The surviving framing elements of a window match the framing elements of the opening on the other side, seen at the far right of the west elevation. Hence, the original openings of this room consisted of two windows, typical of a Georgian parlor.

The framing elements of the Georgian section show the original use of the east/west openings. If the cross hall addition is removed, the classic Georgian plan is in place: a central door of the hall flanked by two windows. One window serves the large hall and one serves the smaller parlor. As seen in the molding profiles, the hall has more elaborate moldings, and if original, is typical of the hall/parlor scenario, where the public space of the hall has the more high style ornament. It is likely the changes that took place in the Georgian section occurred early, perhaps at the same time the Federal section was built. This is based on both nails and framing elements.

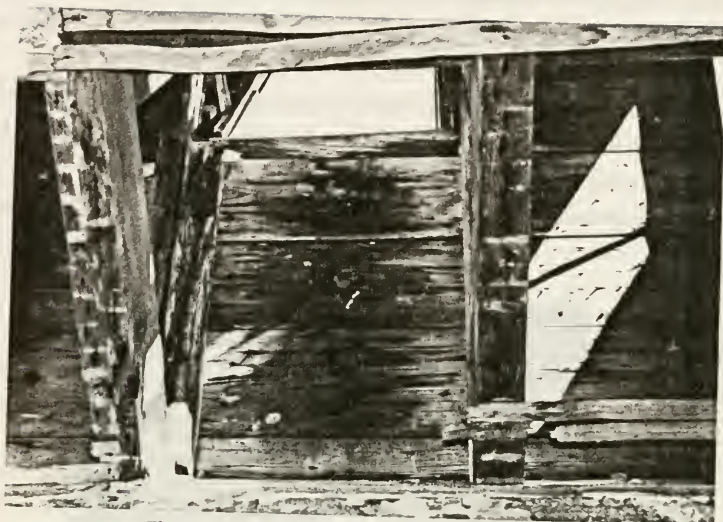
Figure 78: Georgian Dormer Frame Elements

Early alterations were also performed on the second floor of the Georgian section. As seen in both Georgian section elevations, the dormers do not directly line up with the openings below. This is because the carpenters were restricted by the roof frame already in place. They had to cut through one rafter as seen below the sills of the dormers, then installed a companion rafter for structural support. Figures 78 and 79 illustrate this process. Figure 78 shows the original rafter (on the left) cut to make way for the dormer structure. Figure 79 shows a wind brace cut for the same reason, seen on the middle left. Ordinarily, the wind brace would end at the rafter with a half lap joint cut into the rafter rather than the brace being completely sawed off.

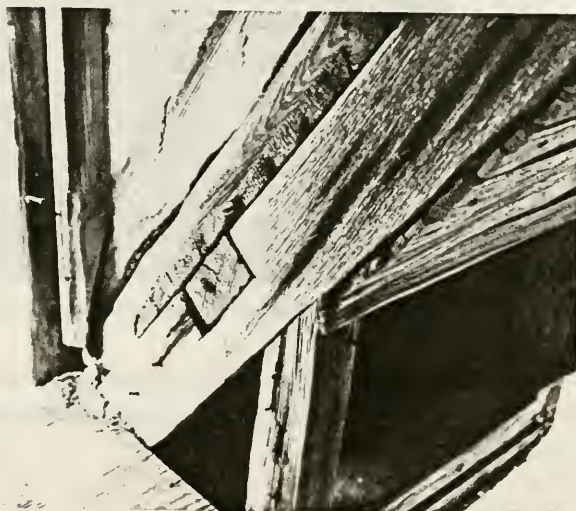
Figure 79: Wind Brace in Georgian Dormer Frame

When the dormers were installed could not be ascertained, but it likely it occurred before the construction of the Federal section because of the lack of Type IIA cut nails in the framing elements. The occupants may have lived on the first floor, then decided to expand into the half story space.

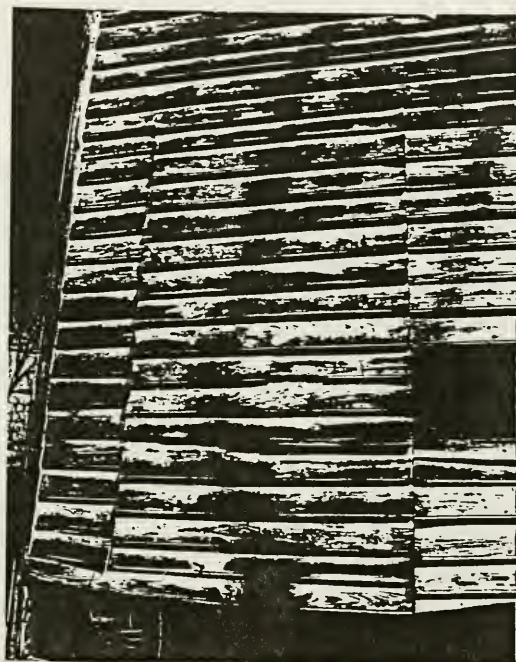
Figure 80: Covered Doorway on Georgian South Elevation

A final alteration in the Georgian parlor occurred late in the building's history. Shown in Figure 80, a door was sided over with weatherboard at the southwest corner of the Georgian south elevation. This door is shown in the L. Scott Garner floor plans of 1964 and was covered at some point afterward. The frame inside is still intact and matches the other jambs in the Georgian/cross hall section.

The date when this doorway was covered is a mystery. In the Garner plans, the door is shown, but is covered in a 1925 photograph seen in Figure 84.

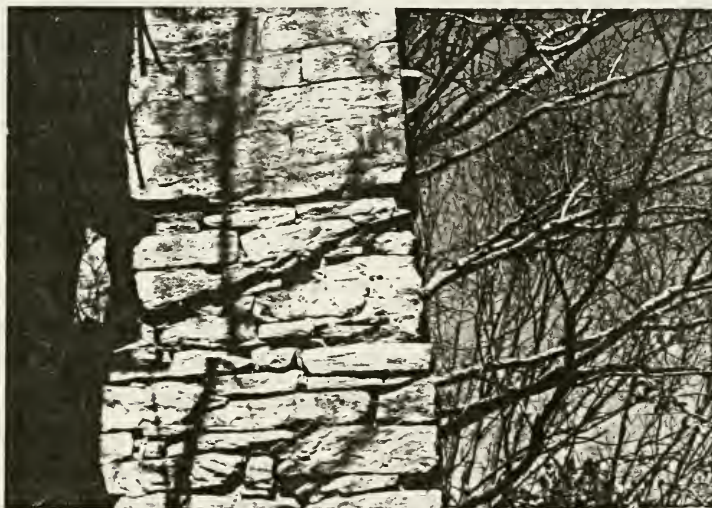
Figure 82: Ghost Mark of Front Gable Roof on South Elevation of Federal East Chimney

The most significant early alteration that occurred at Little Manor, and one that impacts the architectural history of tripartite North Carolina structures, occurred with changes to the Federal wing chamber roofs. In 1998, restoration contractor Dean Ruedrich, with Mitch Wilds, discovered the ghost marks of front gable roofs on the chimneys near the wing chambers. Shown in Figure 82, the mark of a twenty-five degree gable roof is clearly visible.

Ruedrich and Wilds theorized that the original front gable roofs were at some point rotated ninety degrees to give the roof structures their current side gable configuration. The thesis investigation confirms this theory. It begins with a major design flaw during the original Federal construction campaign. The builders were trying to create a tripartite principal elevation with three matching ornamented small front gables beneath one large main front gable. The front gables of the wing rooms were designed to be the same height, roof pitch

Although visually pleasing, the problem with the design is that during rain storms heads of water rush down the roof surfaces of the gables directly onto the chimney and weatherboard of the side elevations of the main massing. Unless very large valley gutters or wide metal flashing materials are used, there is no way the water is prevented from splashing onto the weatherboard and into its overlapping seams. Heads of water can also penetrate into the mortar joints of the chimneys. The result is that these vulnerable areas began to deteriorate rapidly, and the owners were forced to solve the problem by rotating the roof structure to its current form so the flow of water ran off the eaves down onto the ground or into a gutter.
